CASE REPORT

Management of implant fracture: a clinical report

Horia Mihail Barbu¹, Claudia Florina Andreescu¹, Doina Lucia Ghergic¹

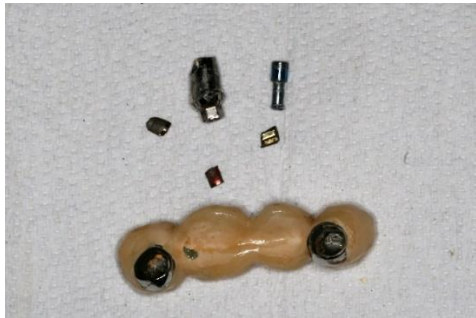
Figure 1.

The bridge was easily removed together with the fractured implant coronal portion (figure 1).

Patient presented with a loose dental bridge. One implant is fractured and also one screw abutment.

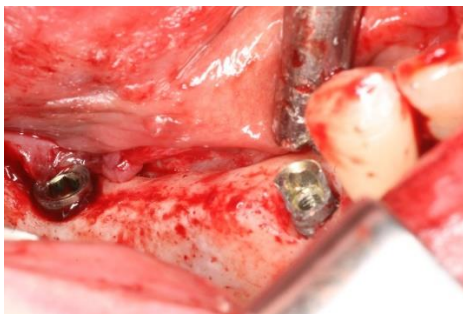
Figure 2.

Exposure of the bone with a full thickness flap utilizing a mid crestal incisions.

Under local anaesthesia (Articaine® 1:100,000 Epinephrine) a mucoperiosteal flap was elevated exposing the fractured implant and one adjacent tooth along with posterior implant (figure 2).

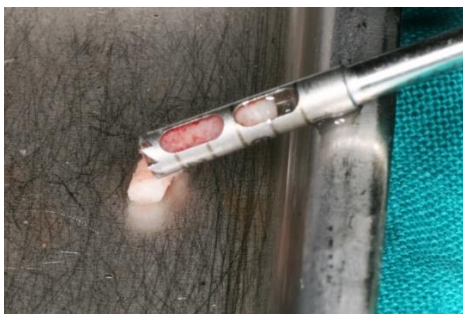
Figure 3.

Bone harvesting with trephine bur from new implant site.

Initially, the sites for implants that replaced second premolar and first molar were prepared. A trephine bur was used to collect bone from osteotomy sites (figure 3). Two implants were placed and then piezotome was used for osteotomy with the purpose of removing fractured implant together with surrounding bone (figure 4,5).

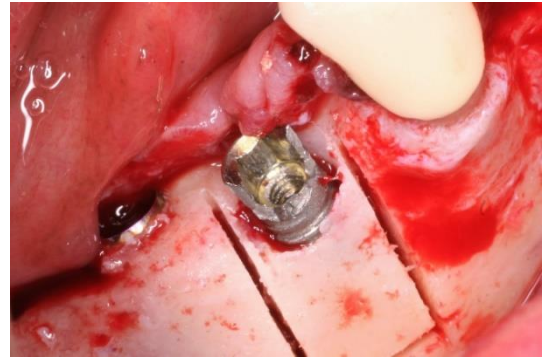
Figure 4.

Placement of additional implants and osteotomy around fractured implant.

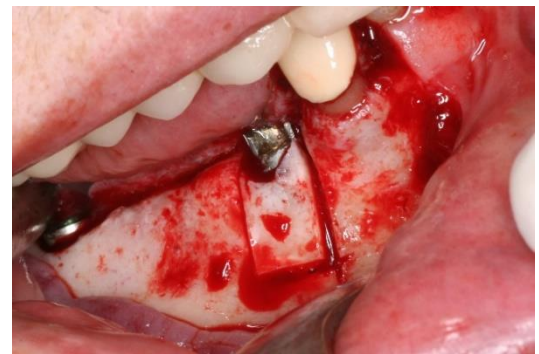
Figure 5.

Osteotomy of cortical bone around fractured implant.

Piezosurgical removal of fractured implant was performed because it has the advantages of easy control, selective cutting, and rapid healing [17].

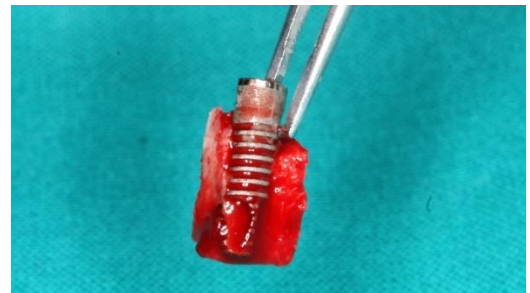
Figure 6.

Osseointegrated implant removed with adjacent bone.

A mixture of autologous material, consisting of harvesting bone from implant sites, bone block from fractured implant and patient blood, and particulate xenograft from bovine material was prepared to regenerate surgical site and promote bone augmentation (figure 6,7,8).

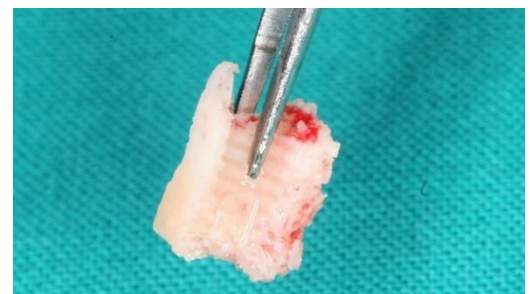
Figure 7.

Implant surrounding bone was collected and prepared to use as bone block to graft osteotomy site.

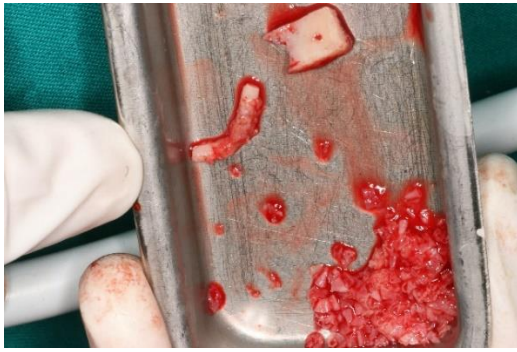
Figure 8.

Mixture of autologous material and xenograft soaked in patient venous blood.

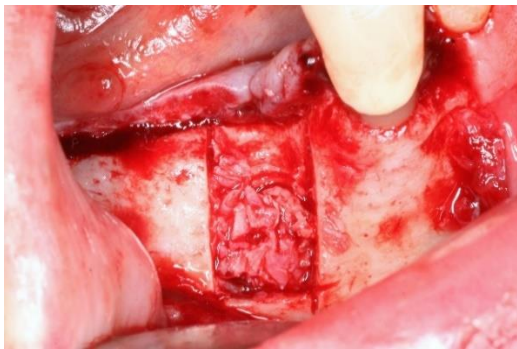
Figure 9.

Surgical site filled with particulate bone.

site was filled with mixture between particulate autologous bone and xenograft (figure 9) and fixation was done to secure the bone block (figure 10). The fixed block was covered with a cardiac membrane and sutures were done in two layers with 4-0 polypropylene (figure 11).

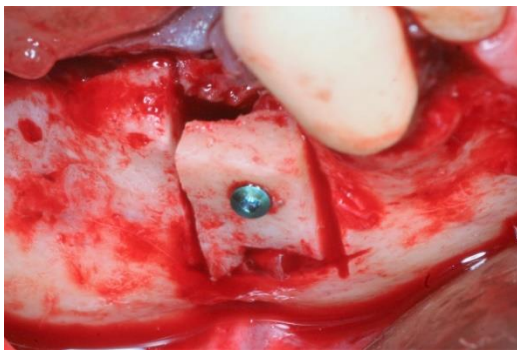
Figure 10.

Fixation of bone block.

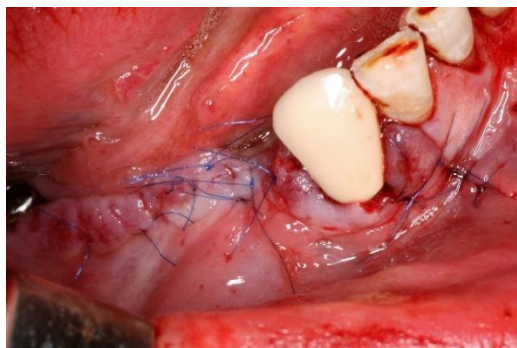
Figure 11.

Postoperative aspect.
