## CASE REPORT

## Evaluation of the therapeutic performance of ICON infiltration resin in the treatment of White Spot Lesions in esthetic dental areas. Clinical Report.

The aim of our study was to assess the effectiveness of treating WSLs with infiltrating resin (Icon, DMG, Hamburg, Germany) and to present the clinical and the aesthetic outcomes in cases of frontal teeth with multiple WSLs [6,7].

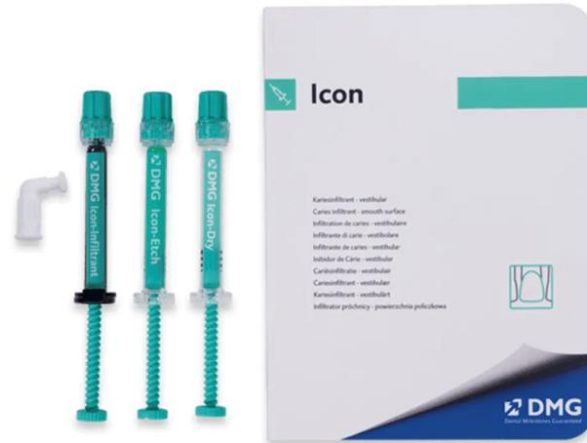
The Icon resin kit includes three syringes (Figure 1):

- Icon-Etch, which contains hydrochloric acid, pyrogenic silicon acid, and a surfactant;
- Icon Dry, which contains 99% ethanol;
- Icon infiltrate, a methacrylate-based resin used for infiltration.

Figure 1. DMG Icon Kit

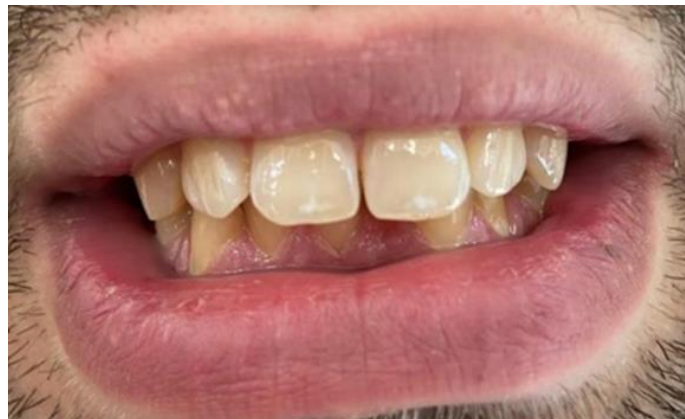
Figure 2. Preoperative image showing WSLs on the upper right and left central incisors

Clinical findings: upon intraoral examination, white spot lesions were noted on the labial surfaces of both upper central incisors. The lesions were well-demarcated, chalky in appearance, and located primarily in the middle third of the crown. There was no evidence of cavitation, and the surrounding enamel appeared to be intact. The radiographic examination did not reveal any subsurface demineralization or pathology. Based on the clinical presentation, a diagnosis of non-cavitated white spot lesions possibly due to

Prior to the treatment, we conducted a detailed clinical examination to assess the size, location, and depth of the lesion ensuring that the lesion is non-cavitated and confined to the

enamel and we requested intraoral radiographs to confirm that the lesion is limited to the enamel and to rule out any dentin involvement (Figure 2, Figure 3).

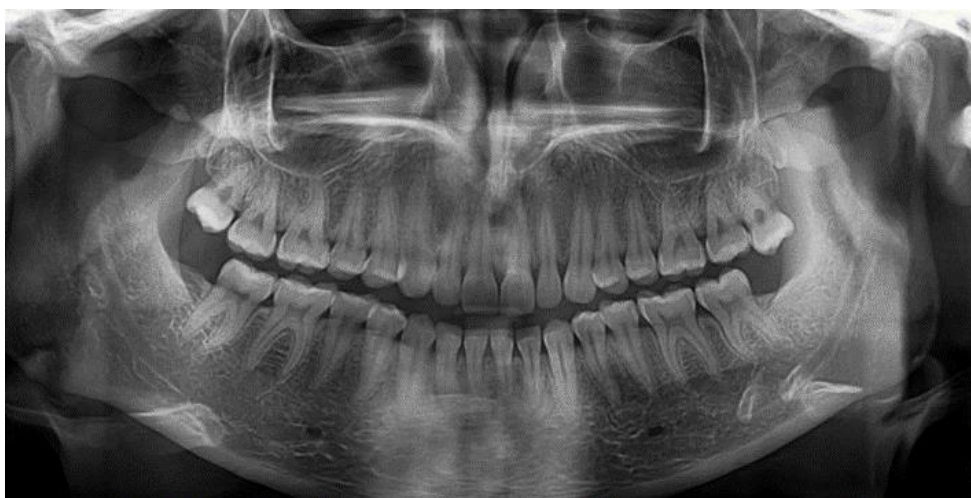
Figure 3. OPT (Orthopantomogram) X-ray showing the intact dental structures on both dental arches

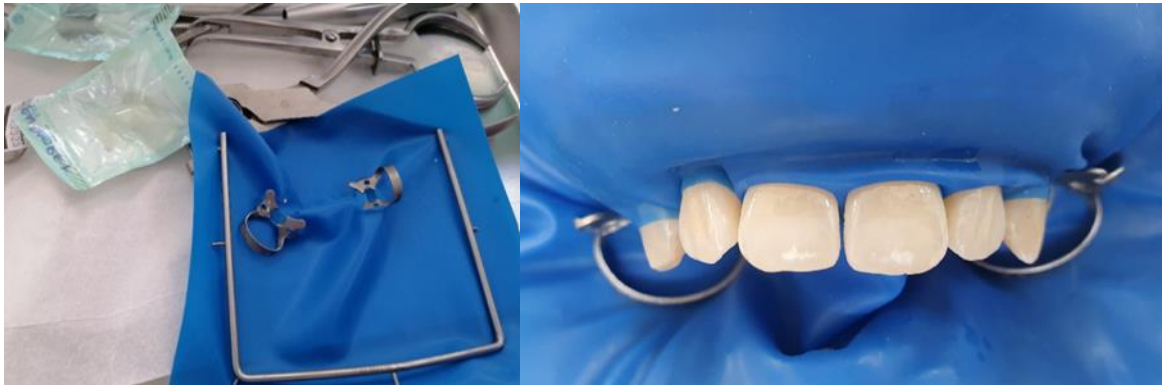
Figure 4. Placement of the rubber dam on the upper incisors

Following the oral prophylaxis, we cleaned the tooth surface with an abrasive paste with a micro brush, and after that, we washed it with water to remove any plaque or debris. We applied a rubber dam to isolate the affected tooth and to protect the soft tissues and adjacent teeth (Fig.4). The following step was the application of etch on the surface and

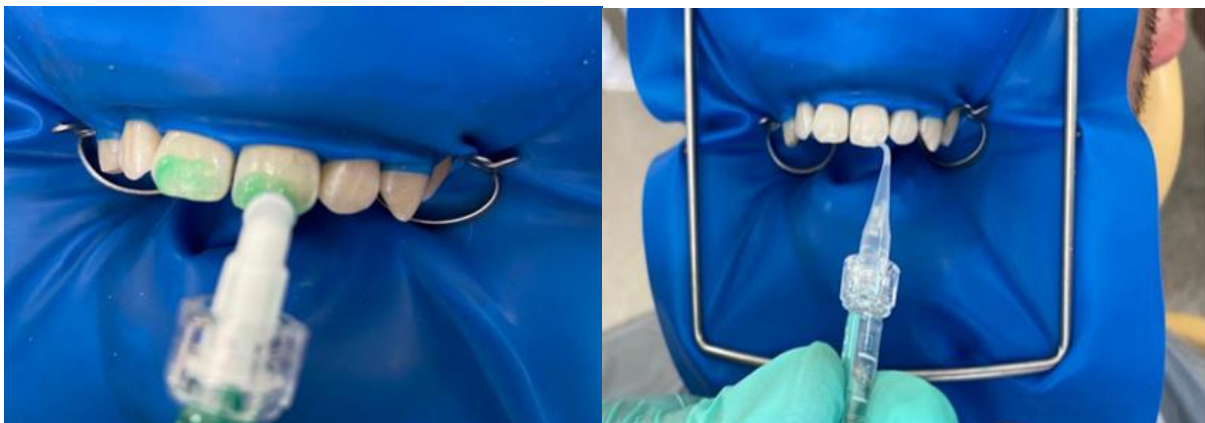
Figure 5. Application of Icon-Etch and the application of Icon-Dry.

preparation of the lesion by applying 15% hydrochloric acid gel for 60 seconds to erode the surface layer of enamel and open up the porosities. This step was followed by rinsing thoroughly with water for at least 30 seconds to remove the etching gel. Next, we gently air-dried the area to ensure that the lesion was fully dried.

We applied Icon-Dry (ethanol) to the lesion for 30 seconds to help in the desiccation of the lesion and to enhance the penetration of the resin followed by the Icon infiltrate resin to the lesion, ensuring full coverage.

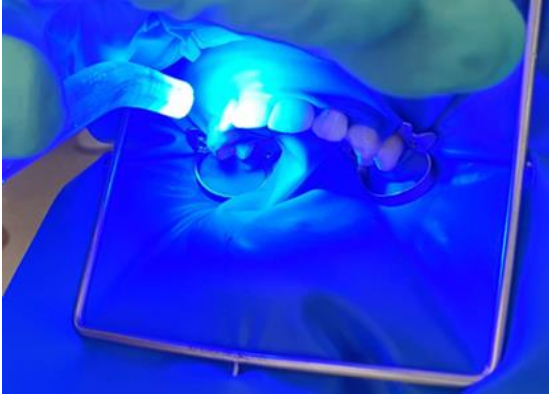
Figure 6. Light curing for 40 seconds the resin layer

We allowed it to penetrate for 3 minutes, and then we used the curing light to polymerize the resin for 40 seconds. A second layer of Icon infiltrate resin we applied and allowed to penetrate for 1 minute, followed by light curing for 40 seconds (Figure 5, Figure 6).

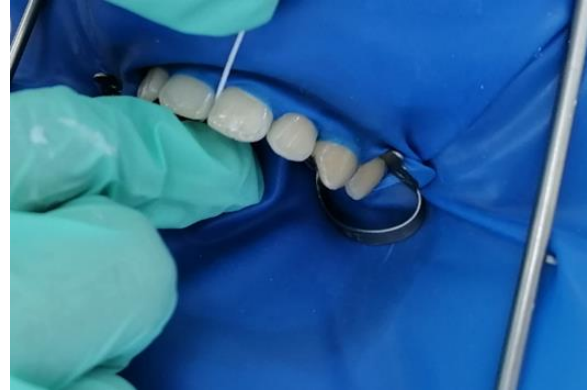
Figure 7. Removing any excess resin from the surface using dental floss

We remove any excess resin from the surface and margins with dental instruments or

dental floss, and polished the treated area with fine-grit polishing discs or rubber cups to achieve a smooth, lustrous finish (Figure 7).

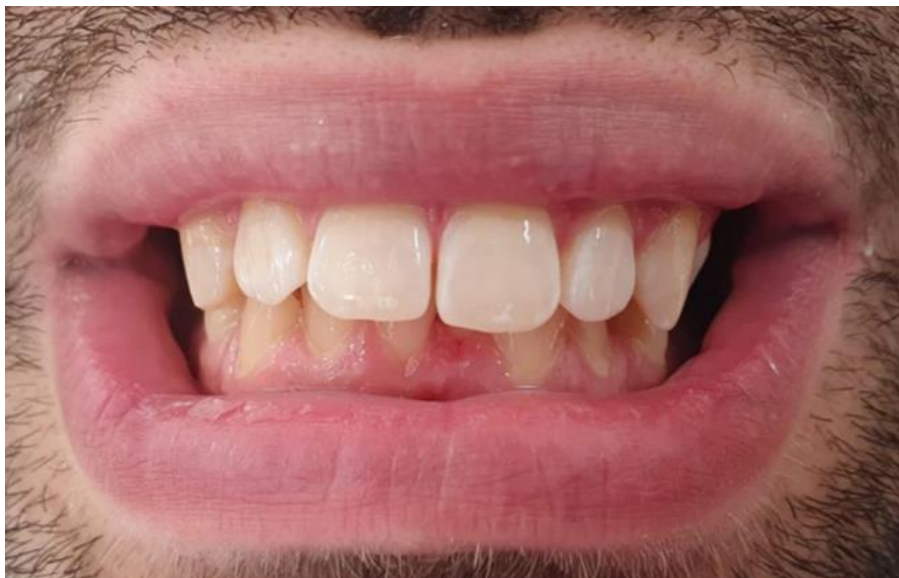
Figure 8. Postoperative image

The purpose of this step is to evaluate the aesthetic outcome (Figure 8), to ensure that the white spot lesion has been masked and the

shade match is satisfactory, and to provide the patient with post-treatment instructions, emphasizing the importance of good oral hygiene.

The patient reported satisfaction with the aesthetic outcome, as the white spots were significantly reduced and the color match with the surrounding enamel was excellent. Follow-up visits at 1 month and 6 months post-treatment showed stable results with no recurrence of the lesions.
